NATIONAL TRANSPORTATION SAFETY BOARD

GROUP CHAIRMAN'S FACTUAL ADDENDUM CONCERNING RE-EXAMINATION OF FUEL PROBES

DCA-96-MA-070

Location : East Moriches, New York
Date : July 17, 1996
Time : 2031 Eastern Daylight Time
Airplane : Boeing 747-131, N93119
Operated as Trans World Airlines (TWA) Flight 800

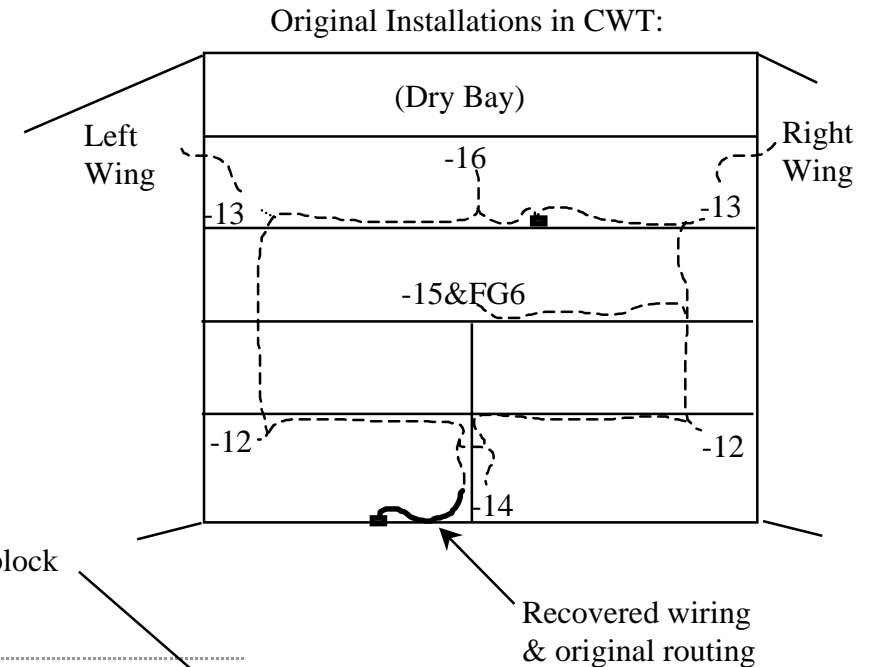
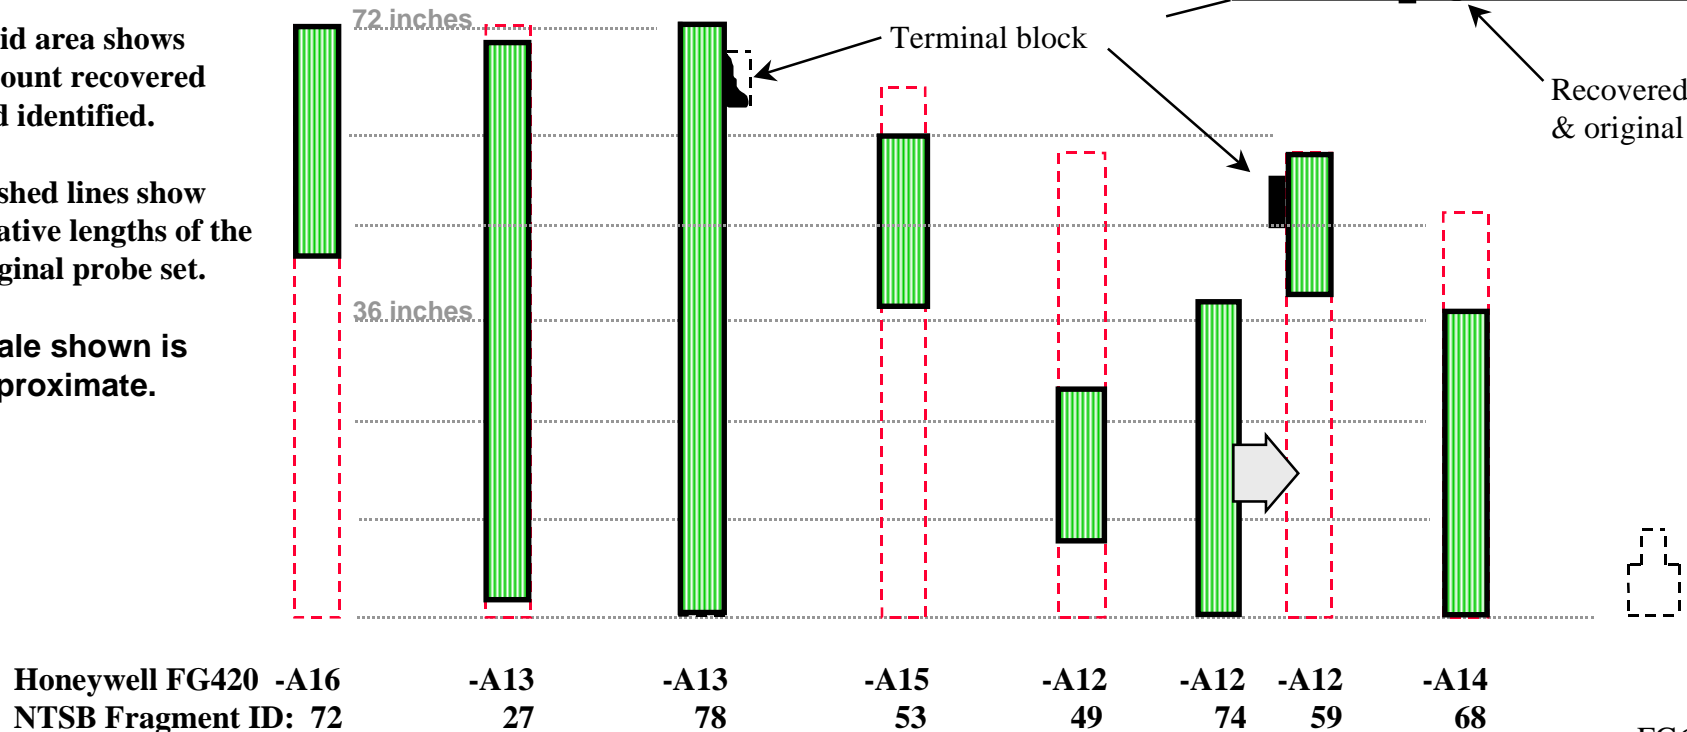
CWT Fuel Probe Fragments Recovered and Identified From TWA 800

**Solid area shows
amount recovered
and identified.**

Dashed lines show relative lengths of the original probe set.

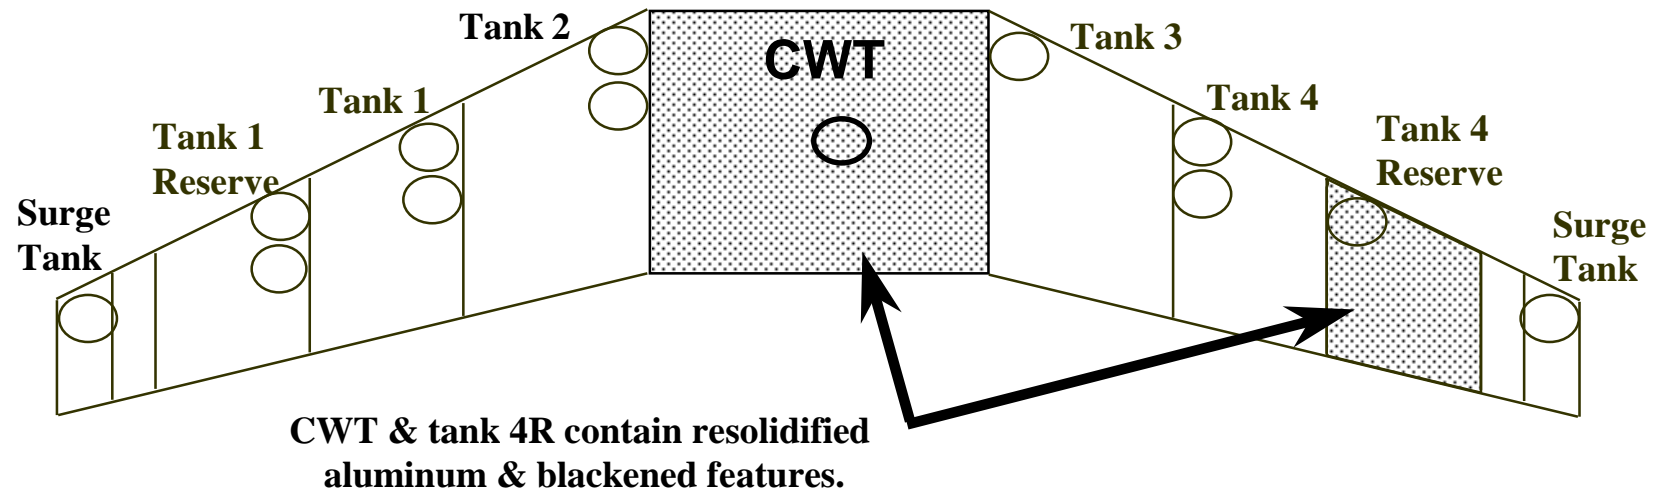
THE 13 ORIGINAL LOCATIONS FOR COMPENSATORS ARE SHOWN AS CIRCLES:

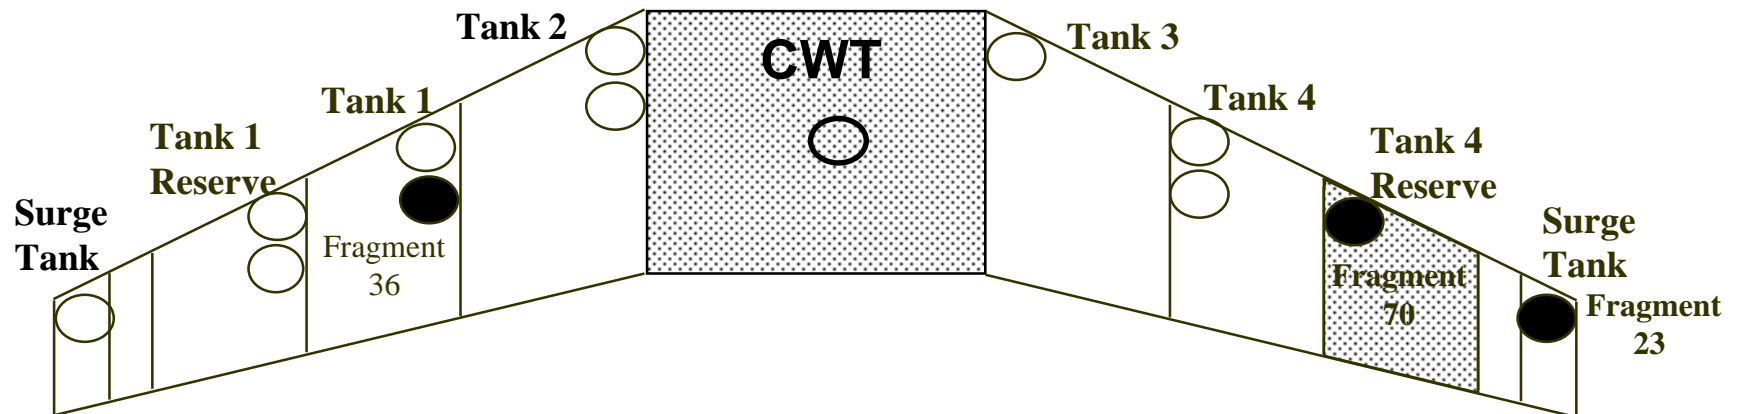
OF THE EIGHT COMPENSATORS FOUND, THREE WERE ATTACHED TO IDENTIFIABLE FUEL TANK WIRES OR STRUCTURE FROM THE LOCATIONS SHOWN AS DARKENED CIRCLES:
